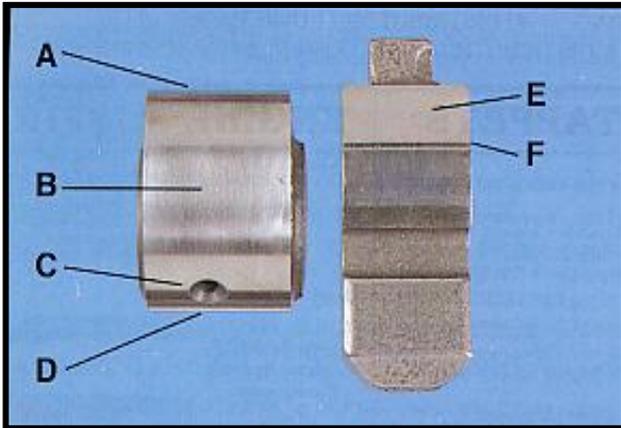
NORMAL APPEARANCE

- 1) Components Clean!
- 2) Running surfaces will develop a polished surface.
- 3) Note "dwell" mark groove which develops as a standard feature on most finger & rocker arm followers. This is the point of maximum cam lift & loading & is not a "wear" problem!

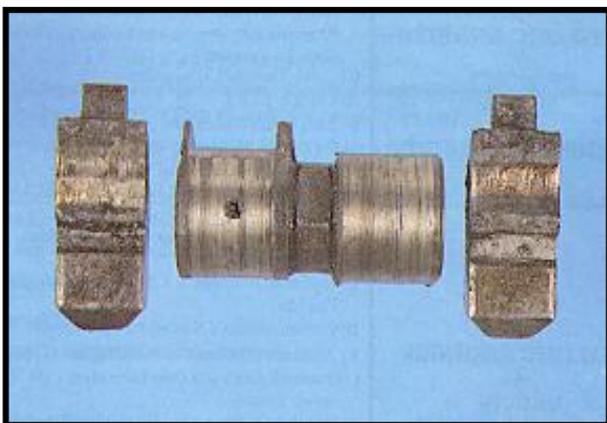
DIRTY OPERATING CONDITIONS

- 1) Components layered with filthy carbonised oil crust.
- 2) Severe wear & metal loss with aggravated scoring.

3) Note oil hole on L/H cam lobe is blocked.

1) Dirty & fuel contaminated oil. Latent heat of engine on close down bakes the dirty oil & forms an ever thickening carbonised crust. Oil ways block & hydraulic columns seize.

2) Resulting lubrication failure promotes wear.

1) Engine requires thorough cleaning which might involve total strip down. Ensure fuel emissions are within MOT requirements. Use top quality lubricant.

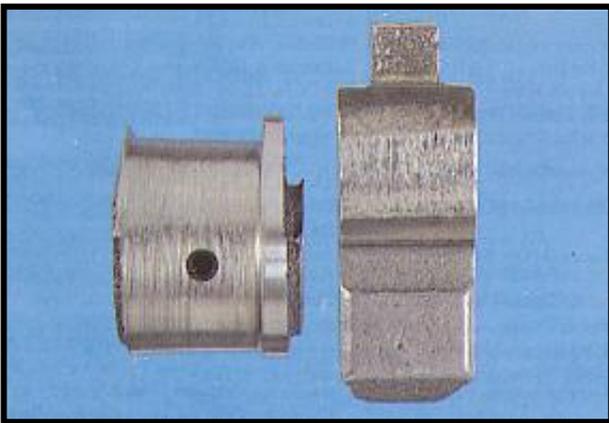
LUBRICATION CLEAN BUT INEFFICIENT

- 1) Components Clean!
- 2) Severe cam wear & metal loss extending to base circle.
- 3) Severe follower face wear over total contact area.

- 1) Pure lack of oil pressure/supply.
- 2) Thin oil due to fuel contamination.
- 3) Old hydraulic ball studs overloading due to inherent contamination.

- 1) Check oil pressure & supply if possible at cylinder head oil gallery plug.
 - 2) Ensure fuel emissions are within MOT requirements.
 - 3) Renew hydraulic ball studs.
-

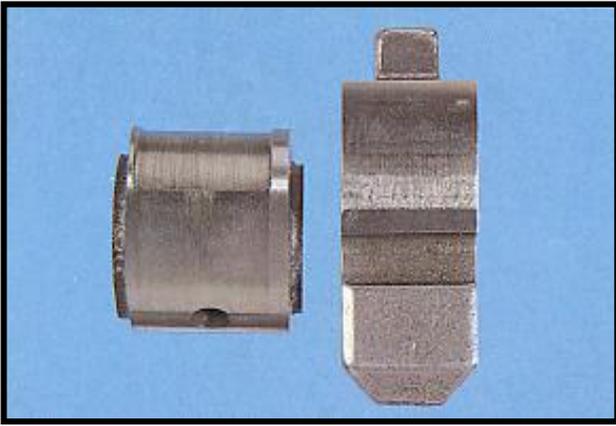
BIASED BALL STUD LOADING

- 1) Components clean.
- 2) Camshaft nose peak worn. Base circle & ramps in maiden condition.
- 3) Follower faces scored at hydraulic ball stud end.

- 1) Overloading of followers due to inefficient hydraulic ball stud.
- 2) Accelerating damage caused by insufficient lubrication at start up.

- 1) Renew hydraulic ball studs.
 - 2) When fitting cam kit, always obtain oil pressure with spark or glow plugs removed.
-

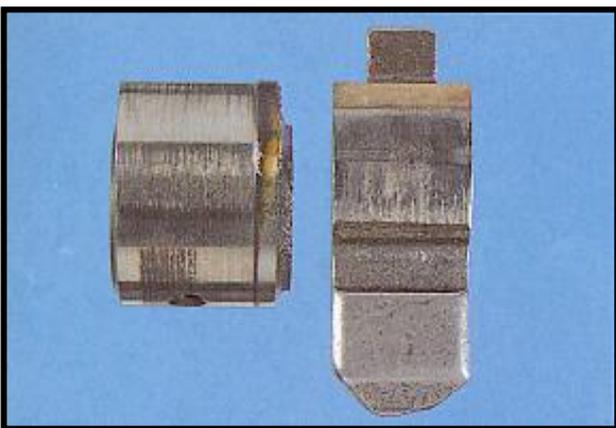
EXCESSIVE HEAT GENERATION

- 1) Camshaft nose peak scored. Yellow to blue tempering colouration on unused edge of cam.
- 2) Follower face beginning to score. Yellow to blue colouration of face ends & sides.

- 1) Poor quality oil or insufficient supply.
- 2) Thin oil due to fuel contamination.

3) General overheating due to coolant or ignition problems.

- 1) Check oil pressure & supply, if possible at cylinder head oil gallery.
 - 2) Ensure fuel emissions are within MOT requirements.
 - 3) Address general overheating causes.
-

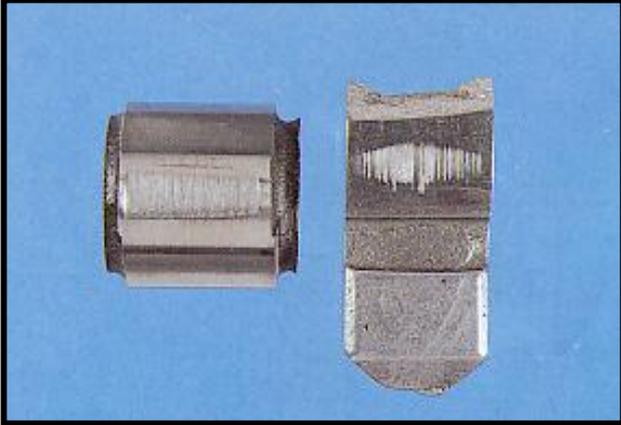
PISTON / VALVE IMPACT

- 1) Cam nose has wear "flat" on its peak.
- 2) Follower has snapped central about face.
- 3) Break is vertical in valve open position.

- 1) Valve & piston collision due to incorrect valve timing or ingress of foreign object into combustion chamber.
- 2) Incorrect diesel cylinder head gasket i.e. too thin.
- 3) Valve spring seating cup assembled upside down causing spring coil binding.

- 1) Correct all above assembly faults.
-

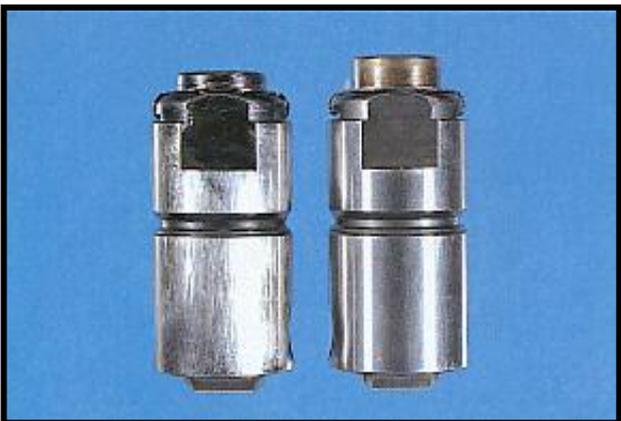
LUBRICANT PARTICLE CONTAMINATION

- 1) L/H failed follower has severe body scratches and top button has collapsed.
- 2) R/H normal follower has polished body. Top button is proud.

- 1) Lubricant contaminated with tiny metal particles, inherent in oil from previous failure.
- 2) Internal parts of follower become scored, seize & collapse.

- 1) Engine requires thorough cleaning which might involve total strip down.
-

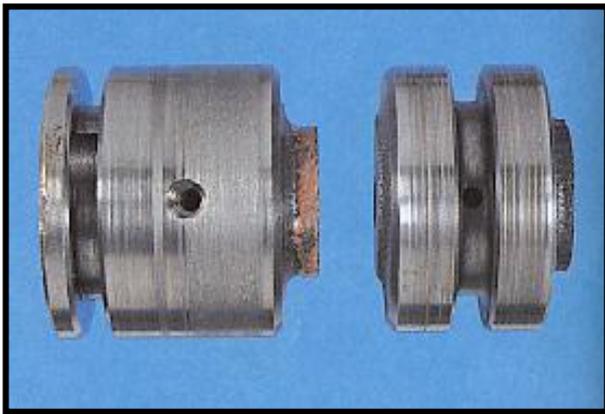
LUBRICANT DEFICIENCY & CONTAMINATION

- 1) L/H main journal has raised metal adhesions.
- 2) Severe wear & metal loss with aggravated scoring.

- 1) L/H main journal has picked up in its housing due to oil pressure not being attained before initial start-up.
- 2) R/H main journal is scored due to inherent particle contamination in lubricant.

- 1) Attain oil pressure before initial start-up.
 - 2) Engine requires thorough cleaning which might involve total strip down.
-

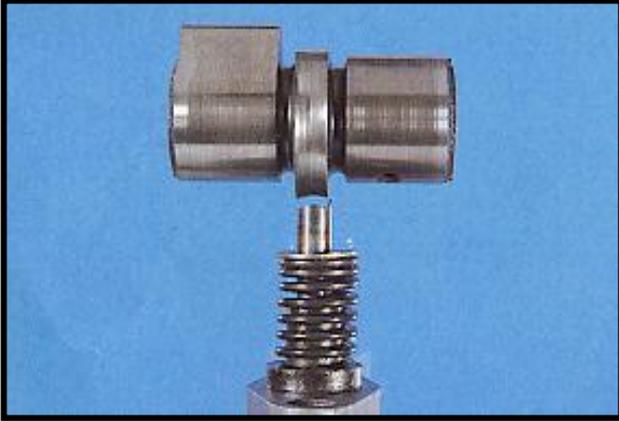
FUEL / VACUUM PUMP ROD WEAR

- 1) Fuel or vacuum pump push rod face is worn. Camshaft pump eccentrics worn to same degree.

- 1) Worn fuel or vacuum pump push rod assembled onto new camshaft.

- 1) Renew parts as required.
-

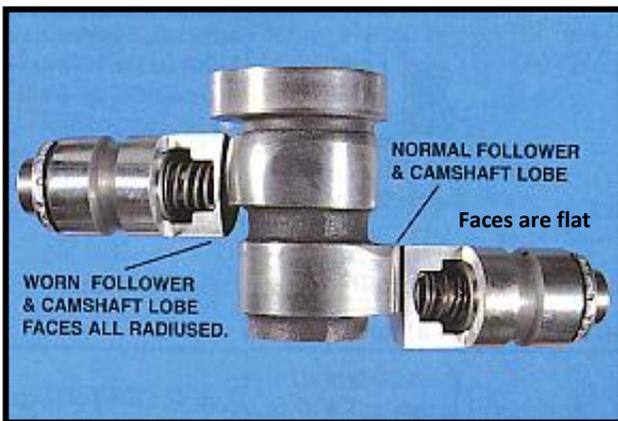
BARREL FOLLOWER WEAR

- 1) L/H couple shows typical radiused face wear compared with normal R/H assembly which is flat. Note dishing in of L/H follower & reduced face thickness.

- 1) Insufficient or inefficient oil supply.
- 2) Particle contamination of lubricant.
- 3) Damage resultant of incorrect start up procedure.
- 4) Incorrect oil filter without anti drain off valve.

- 1) Check oil pressure & supply.
- 2) Check fuel emissions are within MOT requirements.
- 3) Ensure cleanliness of engine & oil ways.
- 4) Follow start up procedures of fitting leaflets.
- 5) Fit O/E or top quality oil filters.

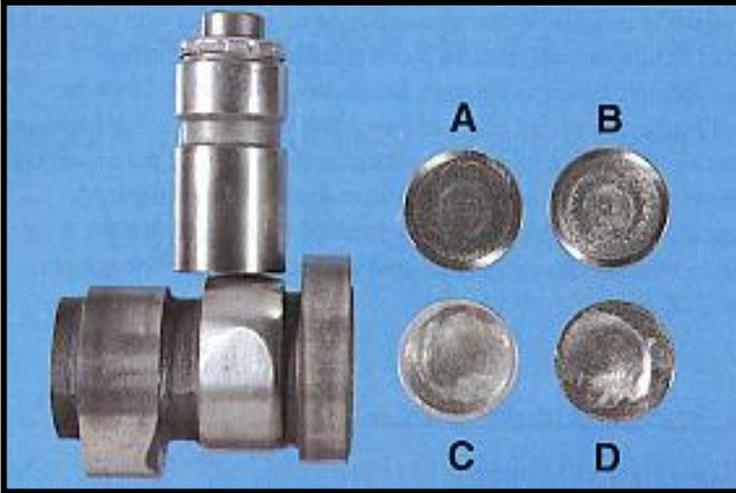
NEW FOLLOWERS FITTED to WORN CAM

- 1) Note point loading of worn cam to face of new follower.

Follower (A) is still rotating but face contact is constrained to the centre causing a massive point contact overload. Follower (B) is still rotating but fatigue pitting & metal loss is developing. Visual dishing of follower face. Follower (C) has stopped spinning & friction & loading has now doubled. Cam lobe & follower face further deteriorate with the wear now extending outwards. Follower (D) will wear cam lobe further aggravated by metal particle contamination. Dishing extends right to the follower edge & fretting develops.

Never fit new followers to existing cams (or vice-versa), particularly if the original faces shows signs of dishing. (As per photograph sequence above).
