Glow Plugs

Fault Finder

"Ultra-glow" diesel heat plugs visual fault finding chart

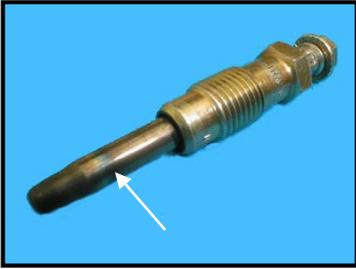
PROBE SURFACE IS CLEAN BUT EXHIBITS RAINBOW TEMPERING COLOURATION HIGH UP THE BLOW TUBE.

- (1) Starter boosting & jump starting.
- (2) Over active timer relay.
- (3) Over active alternator & regulator

- (1) Glow plugs are subjected to an excessive voltage which causes the filament to melt to open circuit. Note! Failure would be immediate.
 - (2) Glow plugs are powered beyond the normal time cycle which reduces the plug life span.
 - (3) Excessive voltage leading to filament melt and open circuit. Note! Failure would not be immediate.
-

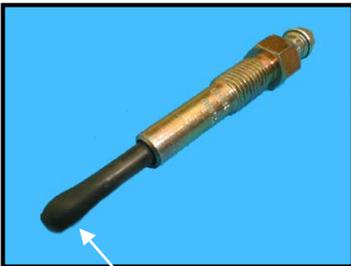
PROBE TIP IS SWOLLEN / BALLOONED

Presence of water moisture within probe.

Expansion of moisture within probe which becomes gaseous and balloons probe tip & leads to ultimate circuit break. Can result after long term parking or due to storage of new stock in damp conditions.

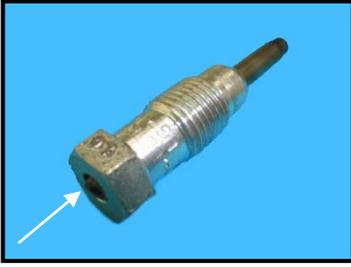
SHEARED GLOW PLUG TERMINAL CONNECTION

- (1) Excessive tightening of retainer. Fitters should use a dedicated "screwdriver - torque driver".
- (2) Mishandling causing breakage of terminal pin.

Fitters do not necessarily realise that they have sheared the internal conductor pin. The plug may operate for some time until the sheared parts separate due to arcing and heat expansion. Failure will then be immediate.

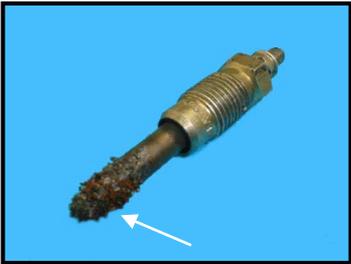
PROBE IS COATED IN A ROUGH LAYER OF RAISED CARBON

- Ingress of oil due to wear via piston rings and / or valve guides
- Excessive fuelling due to worn diesel pump or worn injectors.

Plug probe becomes layered with carbonised fuel / and or oil. The probe can no longer dissipate heat and thus probe core and filament overheat to the point of malfunction.

Note! Failure would not be immediate and might not affect all plugs.

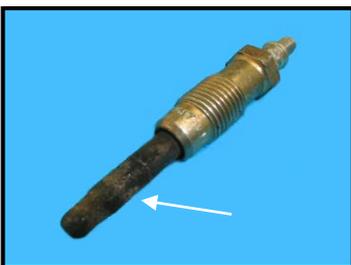
PROBE IS COATED IN A LIGHT SMOOTH COAT OF SOOT OR "BEIGE" COLOURED SCALE.

- Under fuelling due to diesel pump or inefficient injector spray.

Plug environment is subjected to overheating due to a weak mixture.

Constant non operation overheat reduces the probe life span.

Note! Failure would not be immediate and might not affect all plugs.

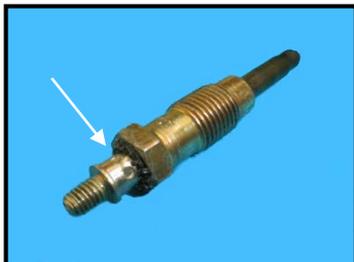
TERMINAL INSULATOR BURNT AWAY

Loose or burnt connection between loom and plug terminal.

Arcing during operation, particularly on a hot engine, can lead to failure of the terminal insulator sleeve. A complete system short would result.

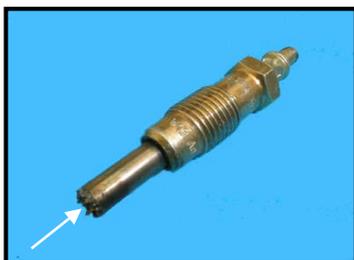
PROBE TIP IS COMPLETELY BURNT AWAY EXPOSING CORE

Any of the previously mentioned causes, but in particular the causes on the first photo at the beginning of this article. Compounded by general overheating.

Glow plugs are subjected to massive voltage overload with possible prolonged energy cycle due to faulty timer.

General overheating will encourage burn out. Plug tip literally melts to destruction.

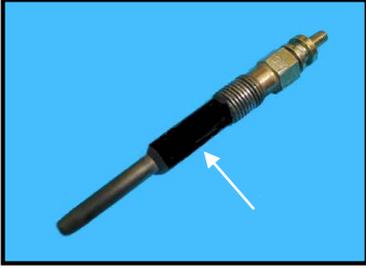
GLOW PLUG BODY IS SOOTY RIGHT UP TO & INCLUDING THE LOWER BODY THREAD

Seating cone has not sealed due to lack of torque or to tightness of thread

Compression ratio is reduced promoting over use of plugs for initial start-up. Damage to head thread can also result.

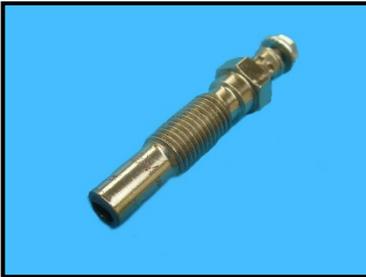
FILAMENT TUBE DETACHMENT

- (1) Starter boosting & jump starting.
- (2) Misdirected injector spray.

- (1) Excessive voltage causes an internal short. The fused wire can arc to earth within the tube & melt a fatigue break through resulting in tube detachment. Plug body is normally tempered brown at the fuse point.
- (2) Fuel spraying directly at the filament tube can instigate a thermal fatigue break due to the hot/cold temperature cycle.
