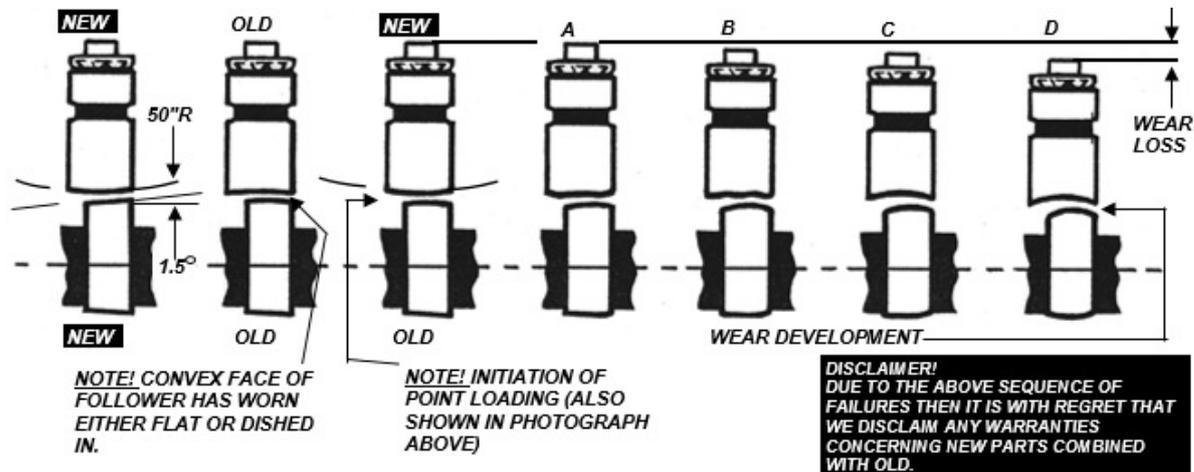
NEW FOLLOWERS FITTED to WORN CAM

- 1) Note point loading of worn cam to face of new follower.

Follower (A) is still rotating but face contact is constrained to the centre causing a massive point contact overload. Follower (B) is still rotating but fatigue pitting & metal loss is developing. Visual dishing of follower face. Follower (C) has stopped spinning & friction & loading has now doubled. Cam lobe & follower face further deteriorate with the wear now extending outwards. Follower (D) will wear cam lobe further aggravated by metal particle contamination. Dishing extends right to the follower edge & fretting develops.

Never fit new followers to existing cams (or vice-versa), particularly if the original faces shows signs of dishing. (As per photograph sequence above).
